**DEPARTMENT OF TRANSPORTATION**

Contract #: 04-0120F4Cty: SF/ALA Rte: 80 PM: 13.2/13.9File #: 69.28**WELDING INSPECTION REPORT****Resident Engineer:**Siegenthaler, Peter**Address:** 333 Burma Road**City:** Oakland, CA 94607**Report No:** WIR-019323**Date Inspected:** 12-Jan-2011**Project Name:** SAS Superstructure**OSM Arrival Time:** 700**Prime Contractor:** American Bridge/Fluor Enterprises, a JV**OSM Departure Time:** 1900**Contractor:** Zhenhua Port Machinery Company, Ltd (ZPMC), Changxing Island **Location:** Shanghai,China**CWI Name:** Cheng Xi**CWI Present:** Yes No**Inspected CWI report:** Yes No N/A**Rod Oven in Use:** Yes No N/A**Electrode to specification:** Yes No N/A**Weld Procedures Followed:** Yes No N/A**Qualified Welders:** Yes No N/A**Verified Joint Fit-up:** Yes No N/A**Approved Drawings:** Yes No N/A**Approved WPS:** Yes No N/A**Delayed / Cancelled:** Yes No N/A**Bridge No:** 34-0006**Component:** OBG**Summary of Items Observed:**

# WELDING INSPECTION REPORT

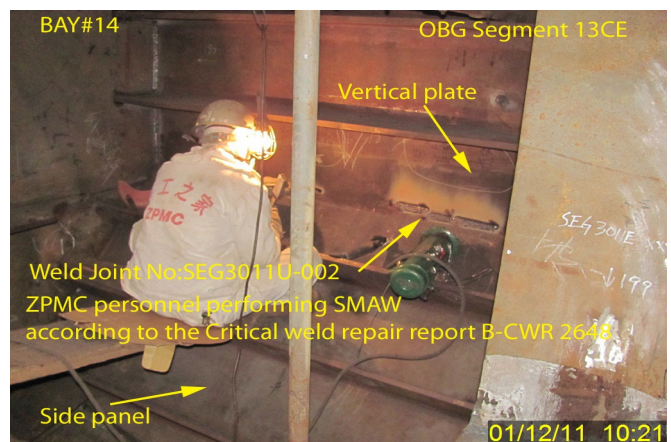
SMAW welding of weld joint no: SEG3011U-002 located on OBG Segment 13CE Vertical plate to Side panel. Welder is identified as #066258. ZPMC CWI is identified as Mr.Cheng Xi. Welding was performed according to the Critical weld repair report B-CWR2648. The welding variables recorded by QC appeared to comply with the WPS-345-SMAW-2G(2F)-FCM-Repair. Please see the attached picture.
